San Francisco-Oakland Bay Bridge: Post-Tensioned solution for retrofit of broken bolts

Location: PTI convention / Norfolk, VA
Date: May 5th, 2014

Presented by: Michael Schwager, P.E.

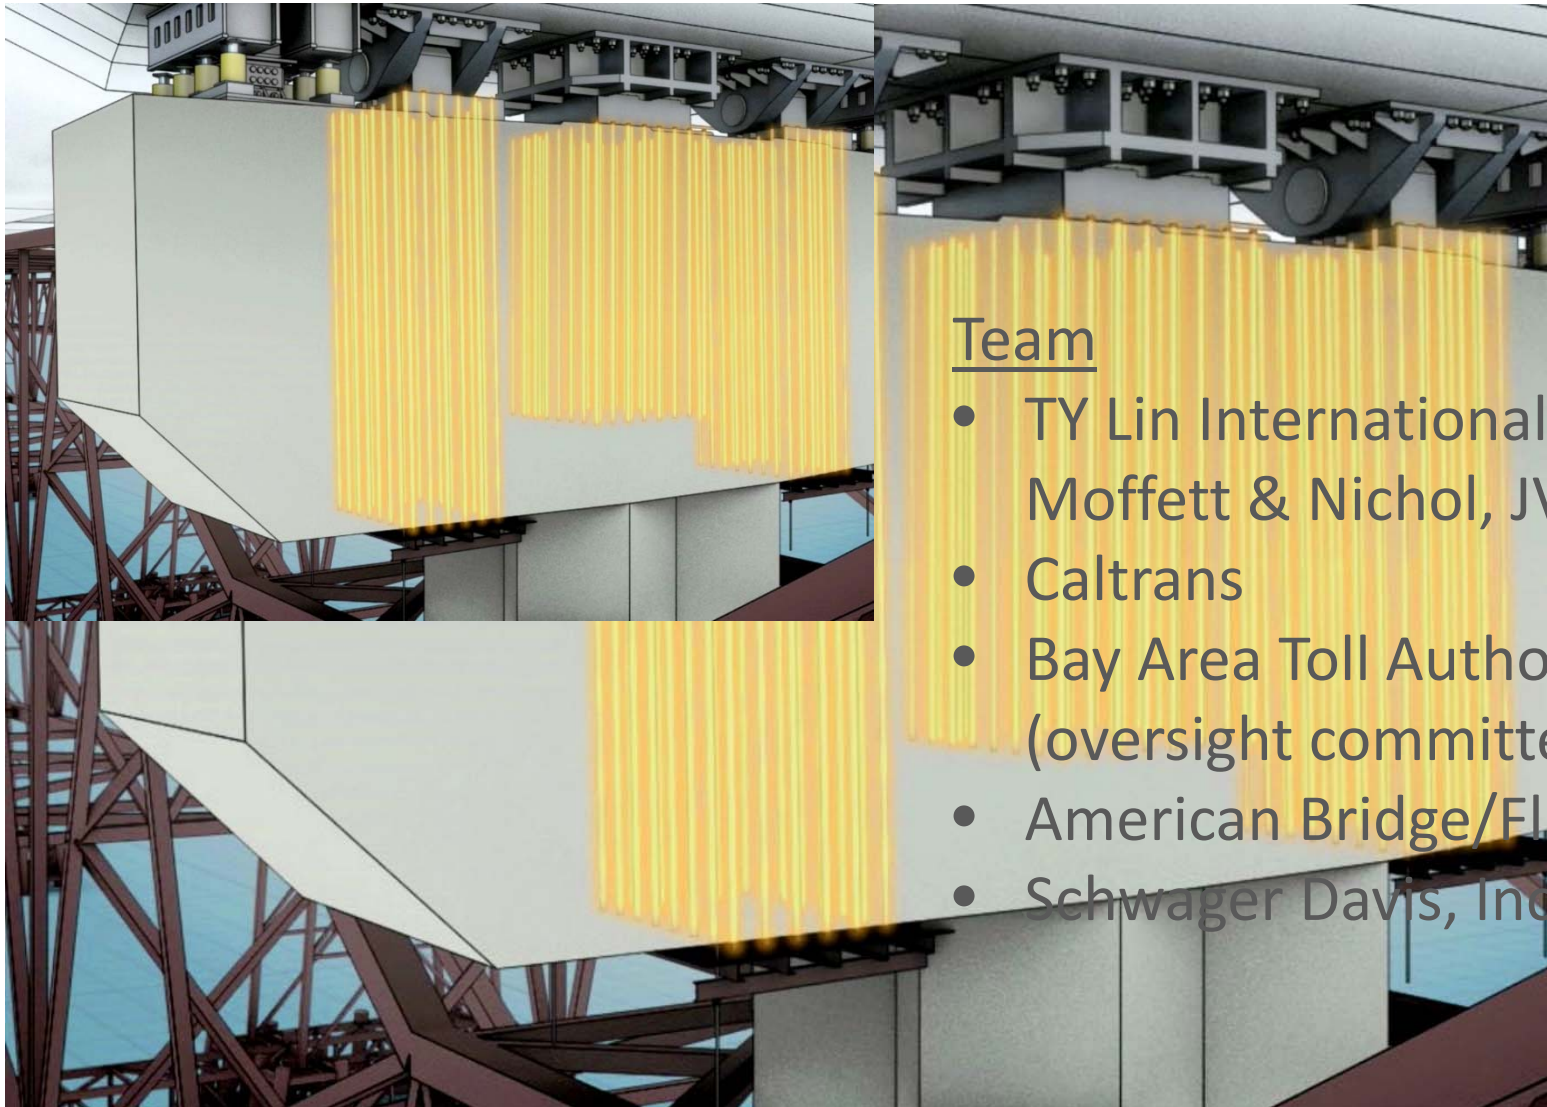
Broken rods

“On March 1, workers began stressing the 96 rods fabricated in 2008 for the two shear keys; between March 8 and March 15, 32 fractured rods were discovered.

Engineers and metallurgists have determined that the bolts broke due to hydrogen embrittlement, which requires a source of excess hydrogen, susceptible material and tension. Ongoing metallurgical analysis revealed that the bolts were susceptible due to the steel being harder on the outside than in the middle, or a lack of uniformity in the steel’s microstructure. The steel also showed low toughness and marginal ductility (the ability to stretch).

The excess hydrogen caused the threaded areas to become brittle and fracture under high tension when the bolts were tightened. An ongoing investigation is looking into the source of the excess hydrogen, which may have been both internal (i.e. residual from production) and/or external.”
