Christopher Fulton, B.Sc.(Eng.)
Lindsey Tourand, P.Eng.
Parsons Brinkerhoff Halsall Inc.

Goal of the study was to answer:

# The Study

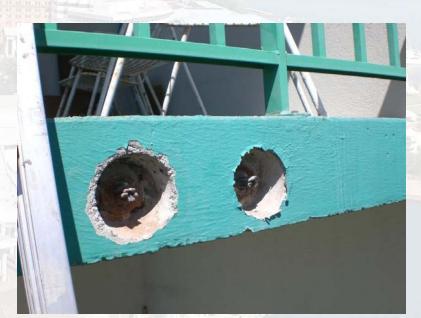
Moisture during construction

Moisture during service

Mechanical damage

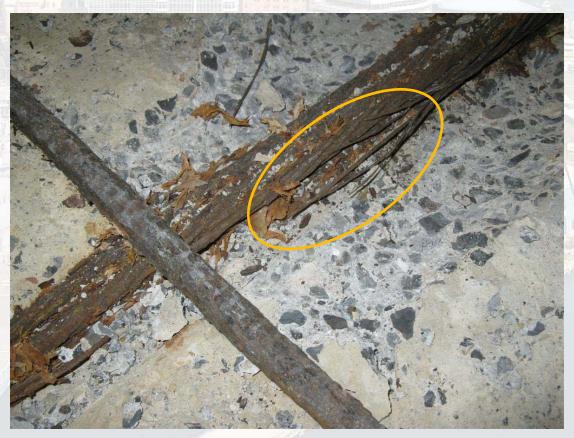
Corrosion from Moisture

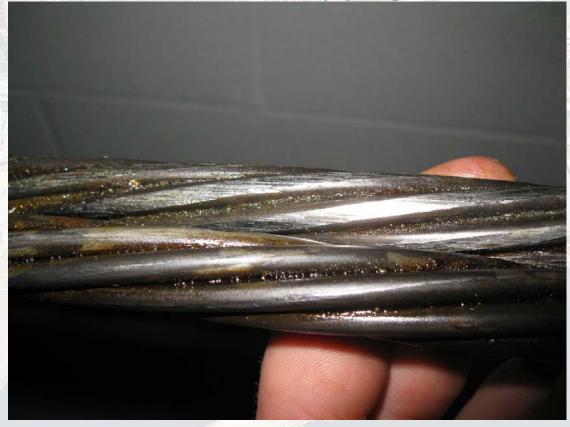
**Anchor Slippage**
