Rehabilitation of a Parking Garage in Downtown Milwaukee, WI

Location:	Milwaukee, WI
Submitted by:	Wiss, Janney, Elstner Associates, Inc.
Owner:	Northwestern Mutual
Engineer(s):	Wiss, Janney, Elstner Associates, Inc.
Contractor:	General Contractor: Structurewerks and PT Subcontractor: STRUCTURAL
PT Supplier:	VSL

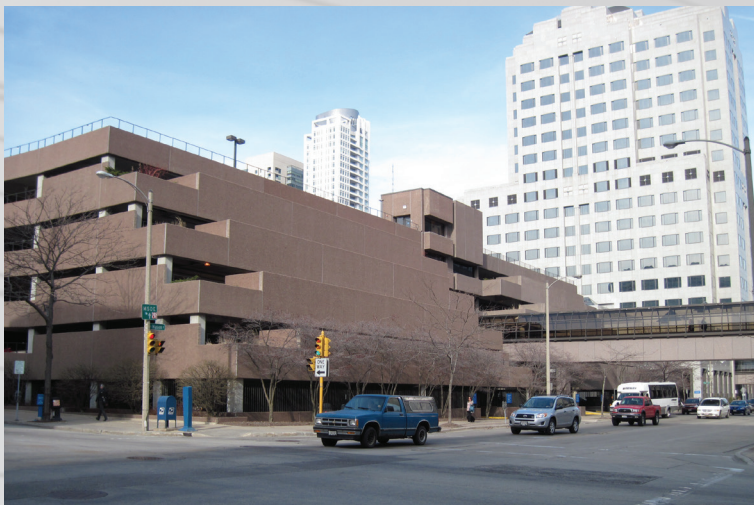
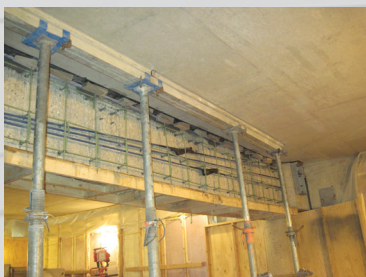
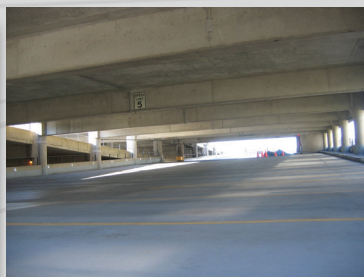
This project included the repair and restressing of almost 600 unbonded slab post-tensioning tendons that had failed or exhibited significant corrosion-related damage. Many of the slab tendons were found to require repair at their end anchorages, where extensive corrosion-related deterioration had occurred due to somewhat unique detailing of the slab edge and inappropriate previous repair attempts. Several other unique conditions at other locations in the garage also contributed to the tendon deterioration. As part of the slab tendon repairs, multiple methods of detensioning were used; many sections of new tendons were replaced using threading and extraction techniques; and all repaired sections of tendons were fully encapsulated, including the spliced connections to the remaining existing tendon sections and the central stressing splices.

The beams addressed as part of this project included a set of beams located at an expansion joint. An unusual condition caused by a construction deficiency allowed water to leak through the failed expansion joint seals and enter the sheathings of the beam tendons, resulting in the corrosion and failure of some of these tendons. To restore the strength of these beams, external post-tensioning was installed on the sides of the beams, which required a unique method of anchoring due to the configuration of the structure at the beam ends. In addition, tendon drying and regreasing techniques were used on these beams to help limit additional beam tendon deterioration in the future.

The structural rehabilitation of this parking garage involved extensive repairs to the slab post-tensioning system. The repair techniques used were tailored to enhance the efficiency of the repairs and durability of the repaired structure. This repair project also used external post-tensioning to strengthen beams where the beam tendons had deteriorated due to corrosion.
