# Corrosion Protection of Grouted Post-Tension Tendons

Garth Fallis, P. Eng.

Vector Corrosion Technologies

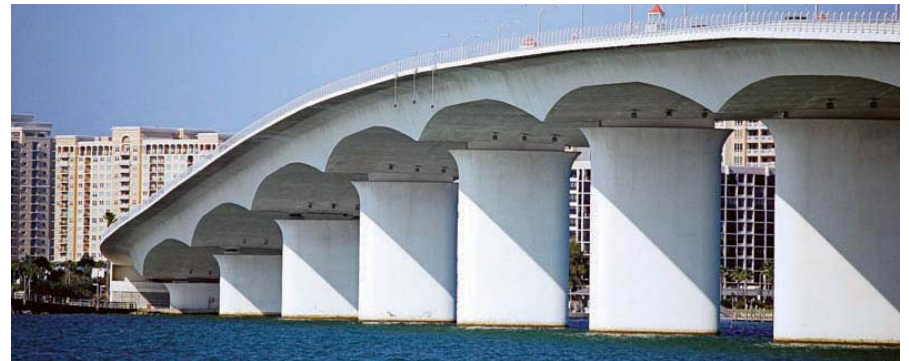
- Grouted Post-Tension Tendon Issues
  1. Bleed water voids
  2. Segregated grout
  3. Soft grout
  4. Chloride contaminated grout
  5. Sulfate contaminated grout

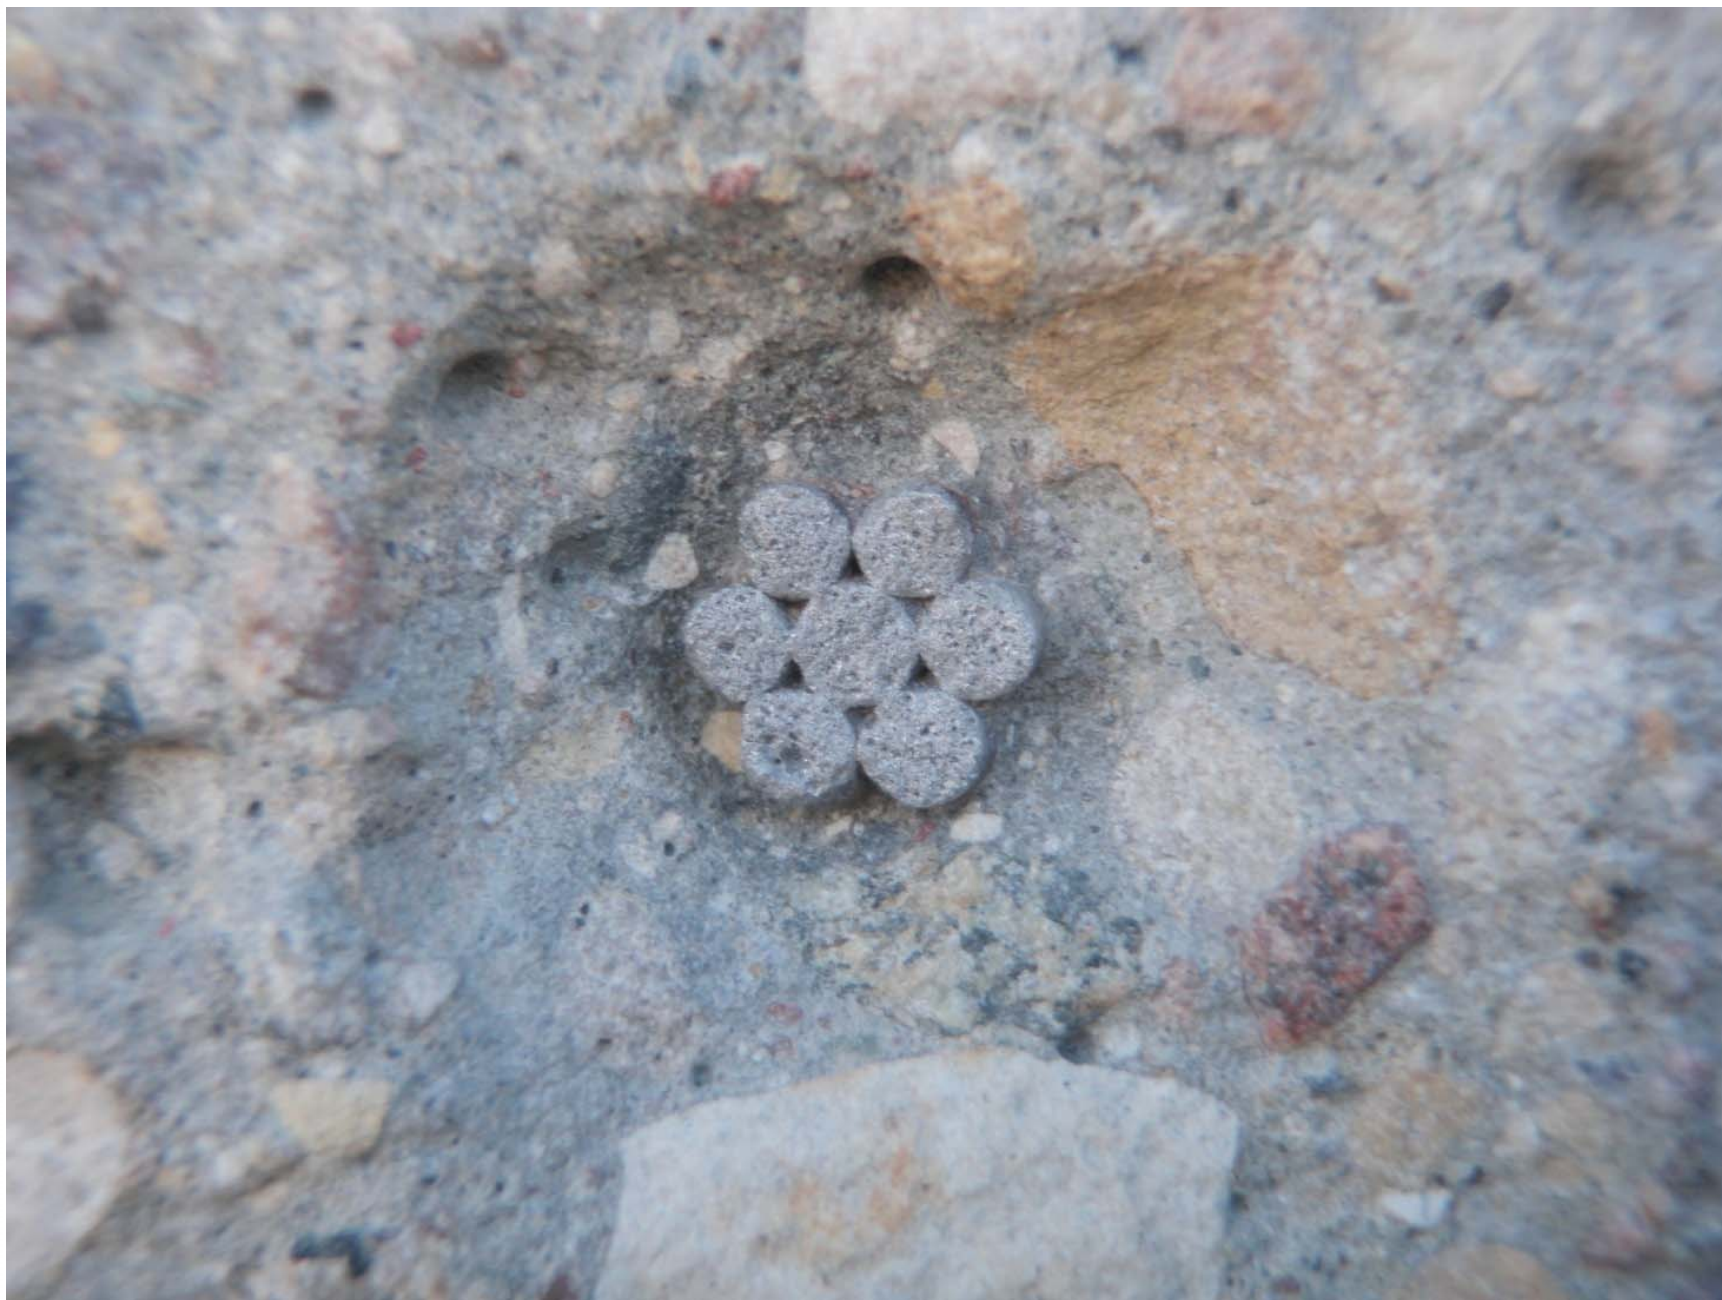
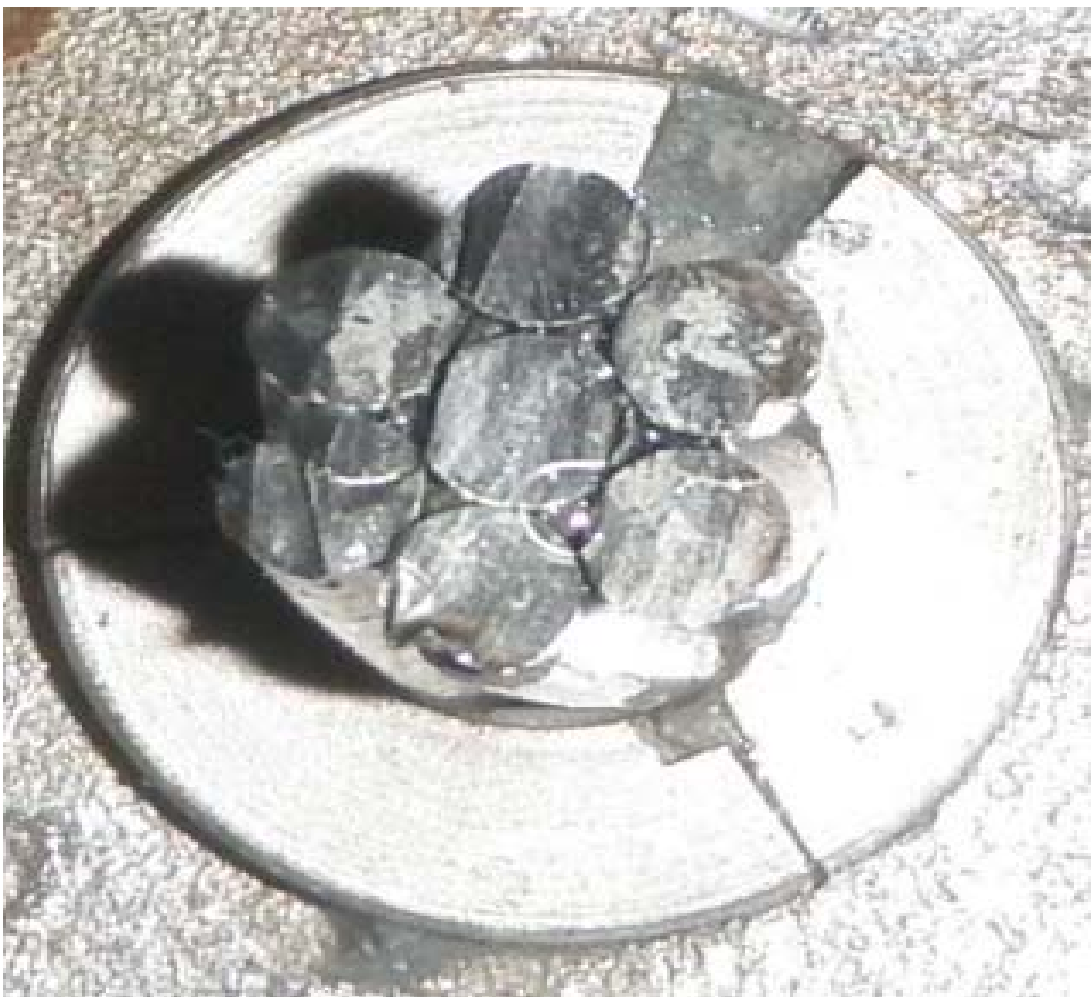
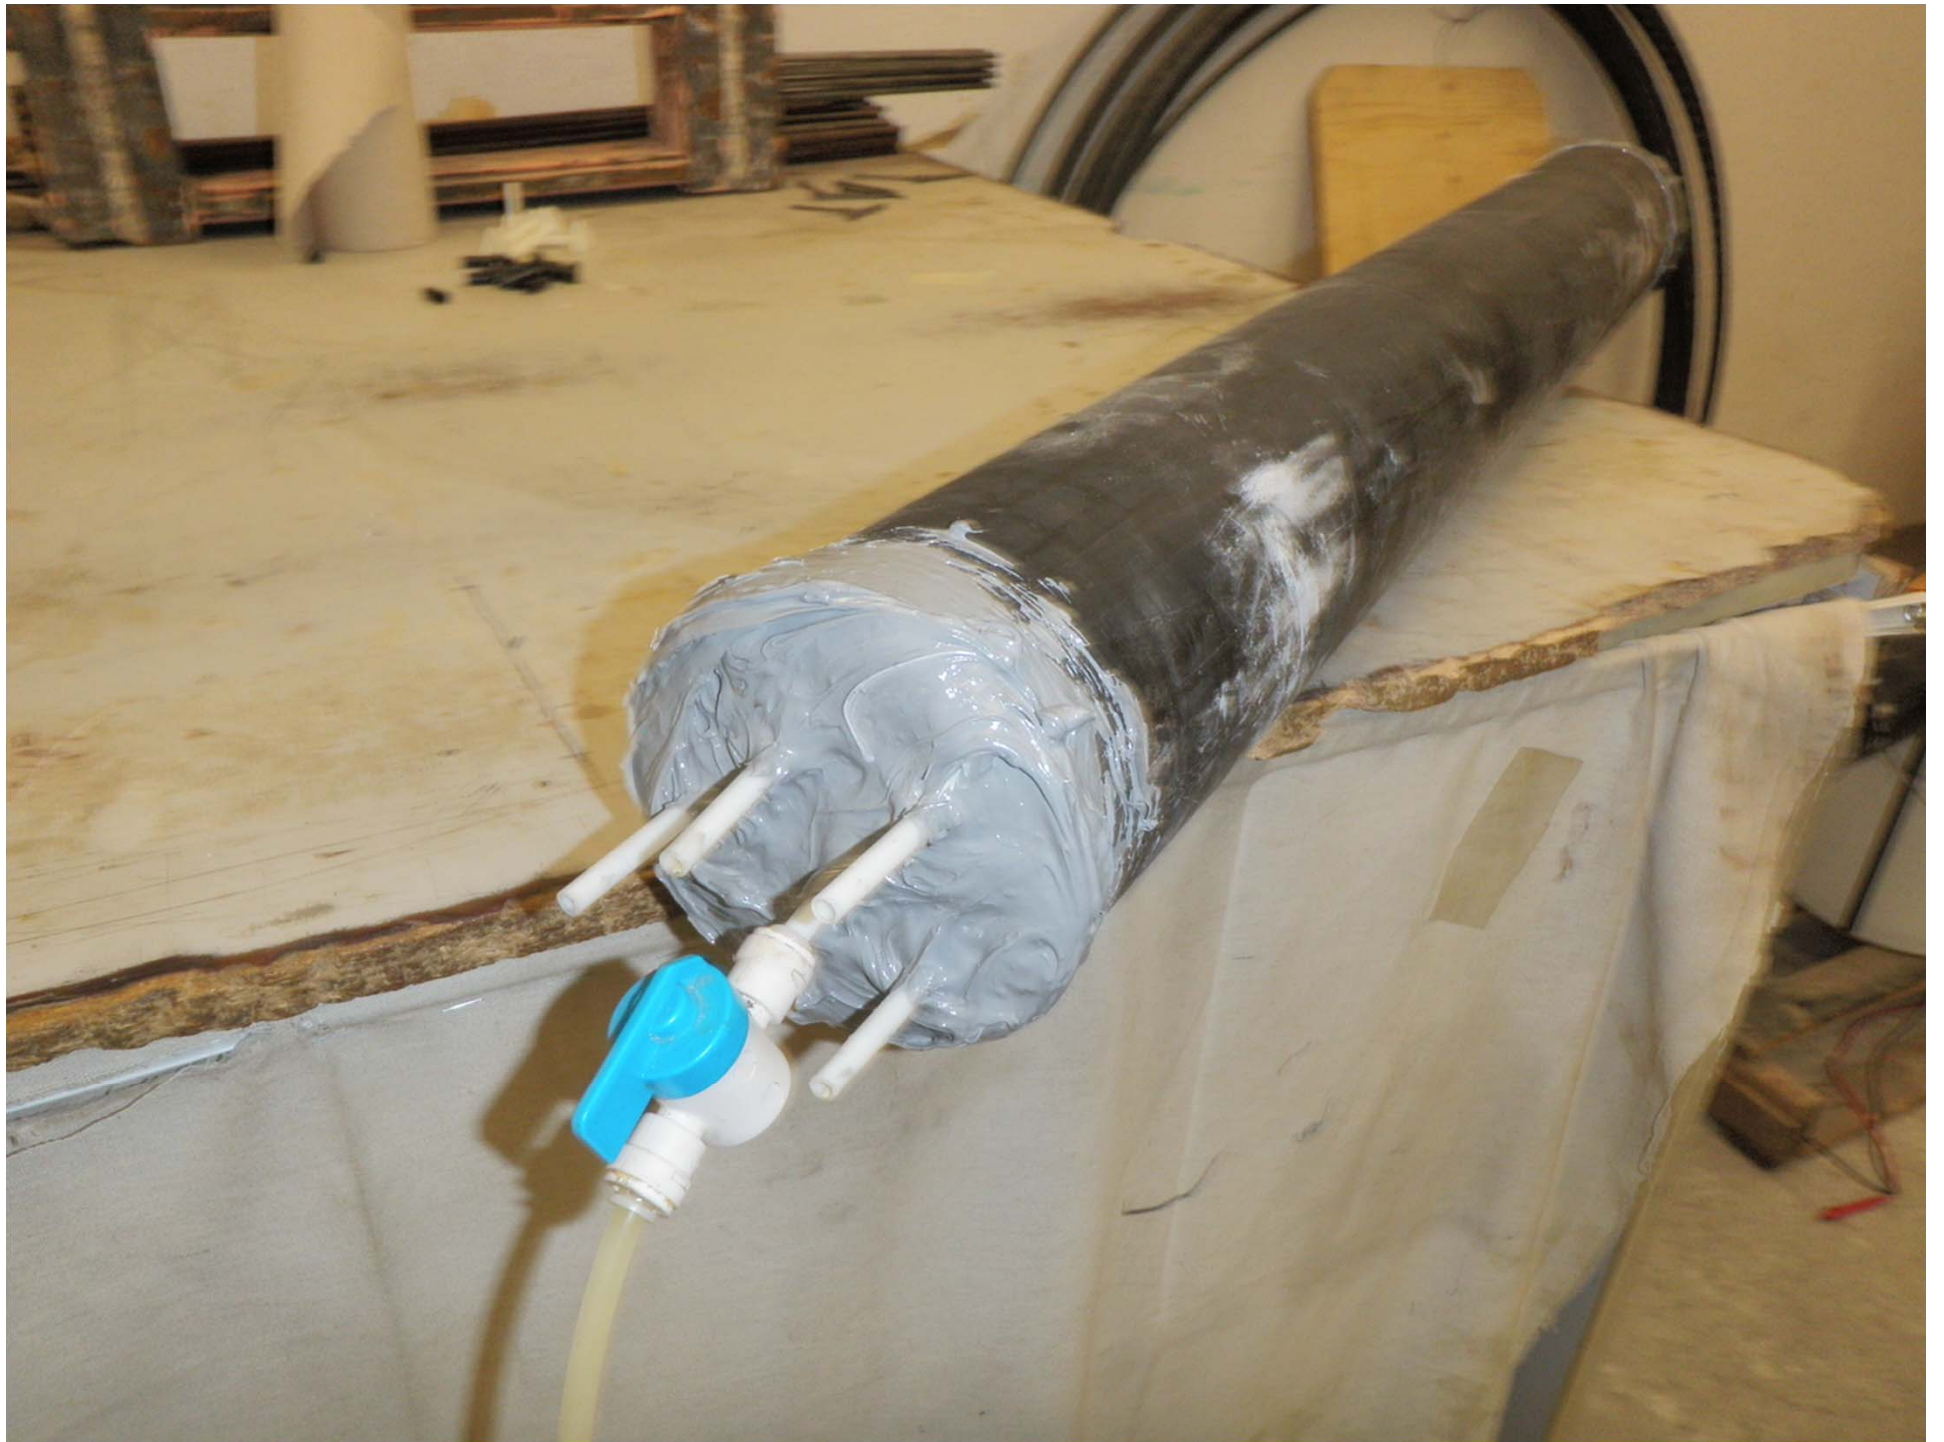
- Corrosion protection for bonded post-tension and pre-stressed cables
- Uses corrosion inhibiting impregnation material
  - To make grout / concrete corrosion resistant
  - Coats exposed steel in voids to form a film and prevent corrosion

Corrosion Impregnation material can be pumped over 250 ft in a tendon

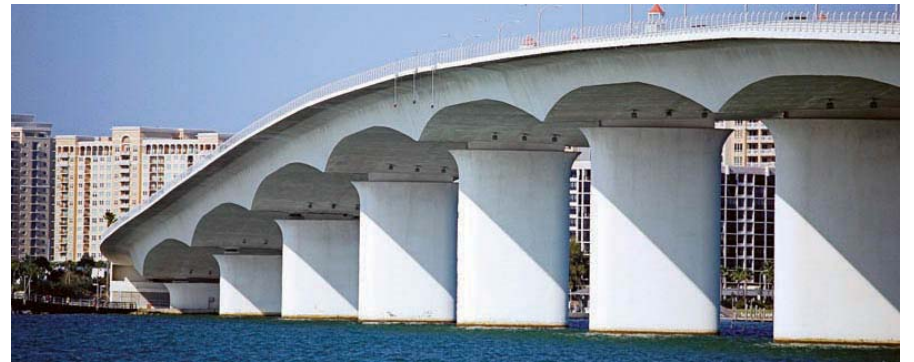
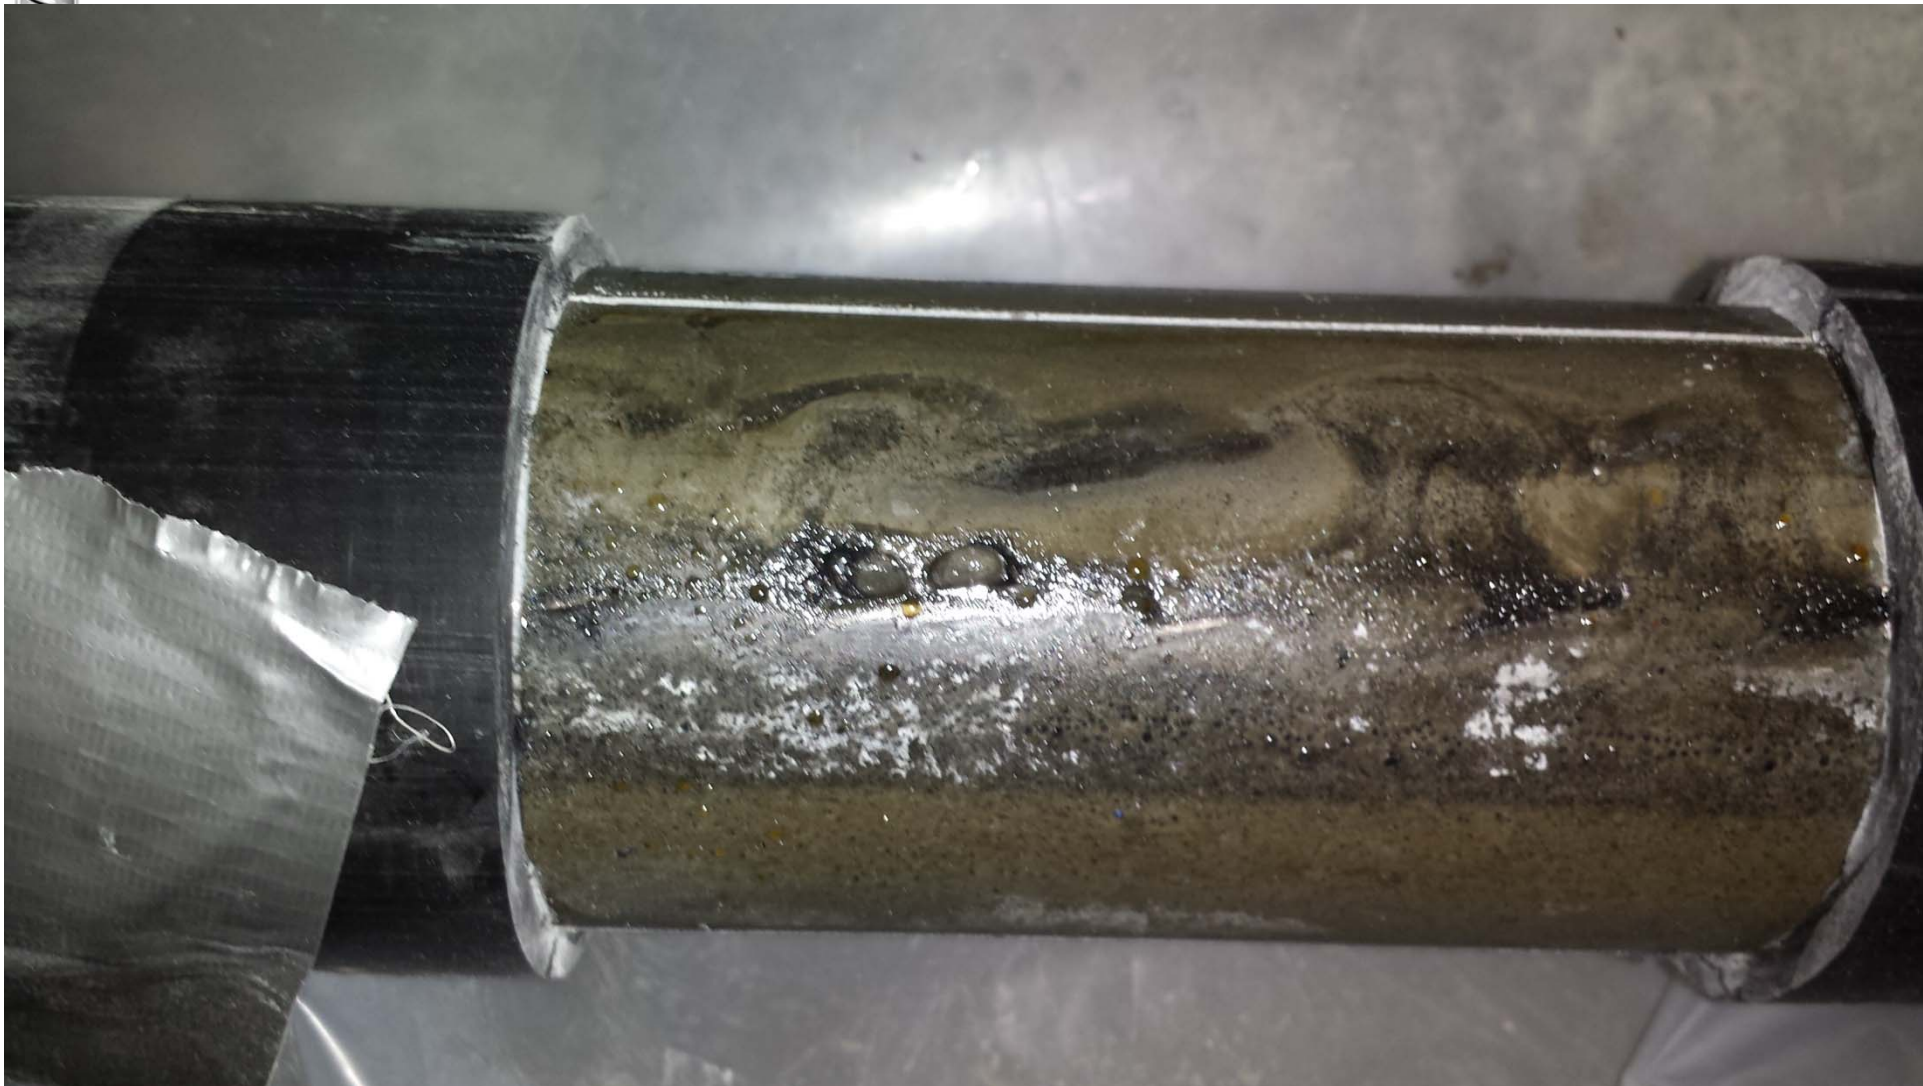
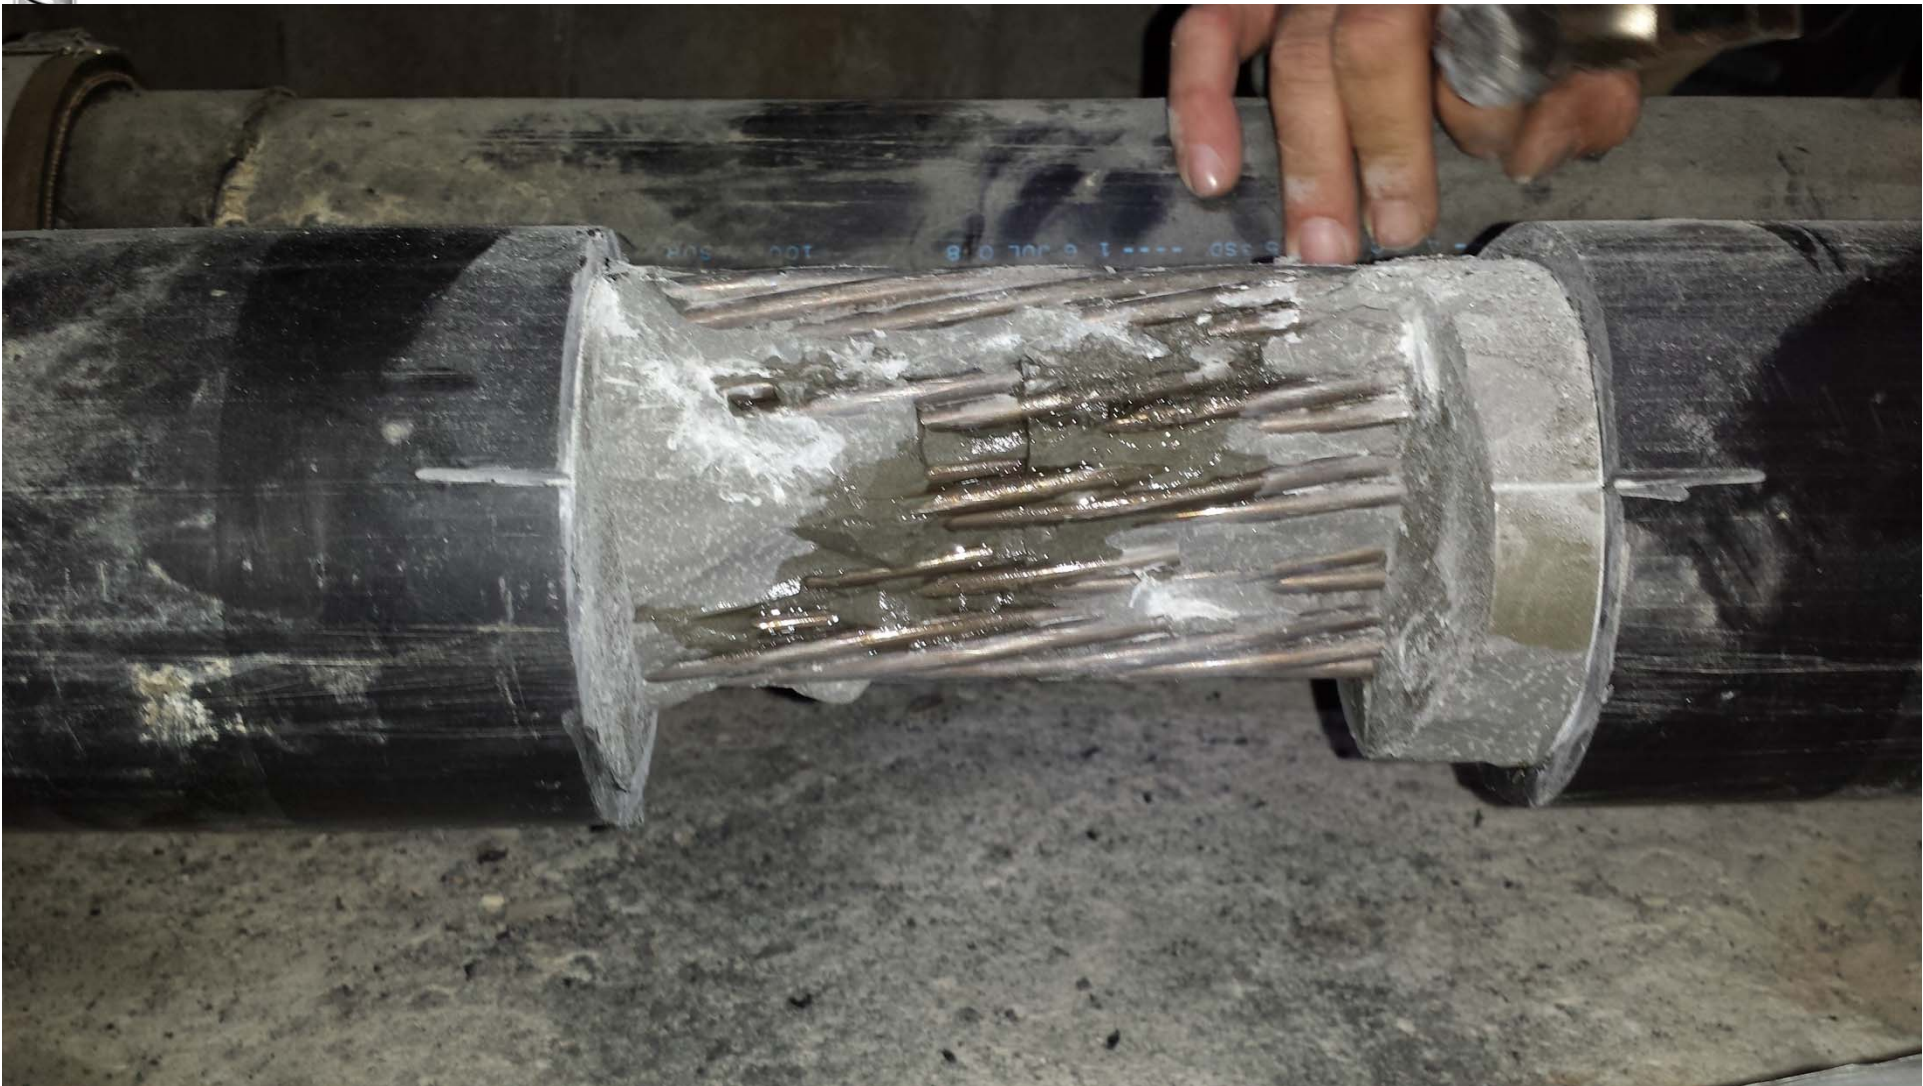
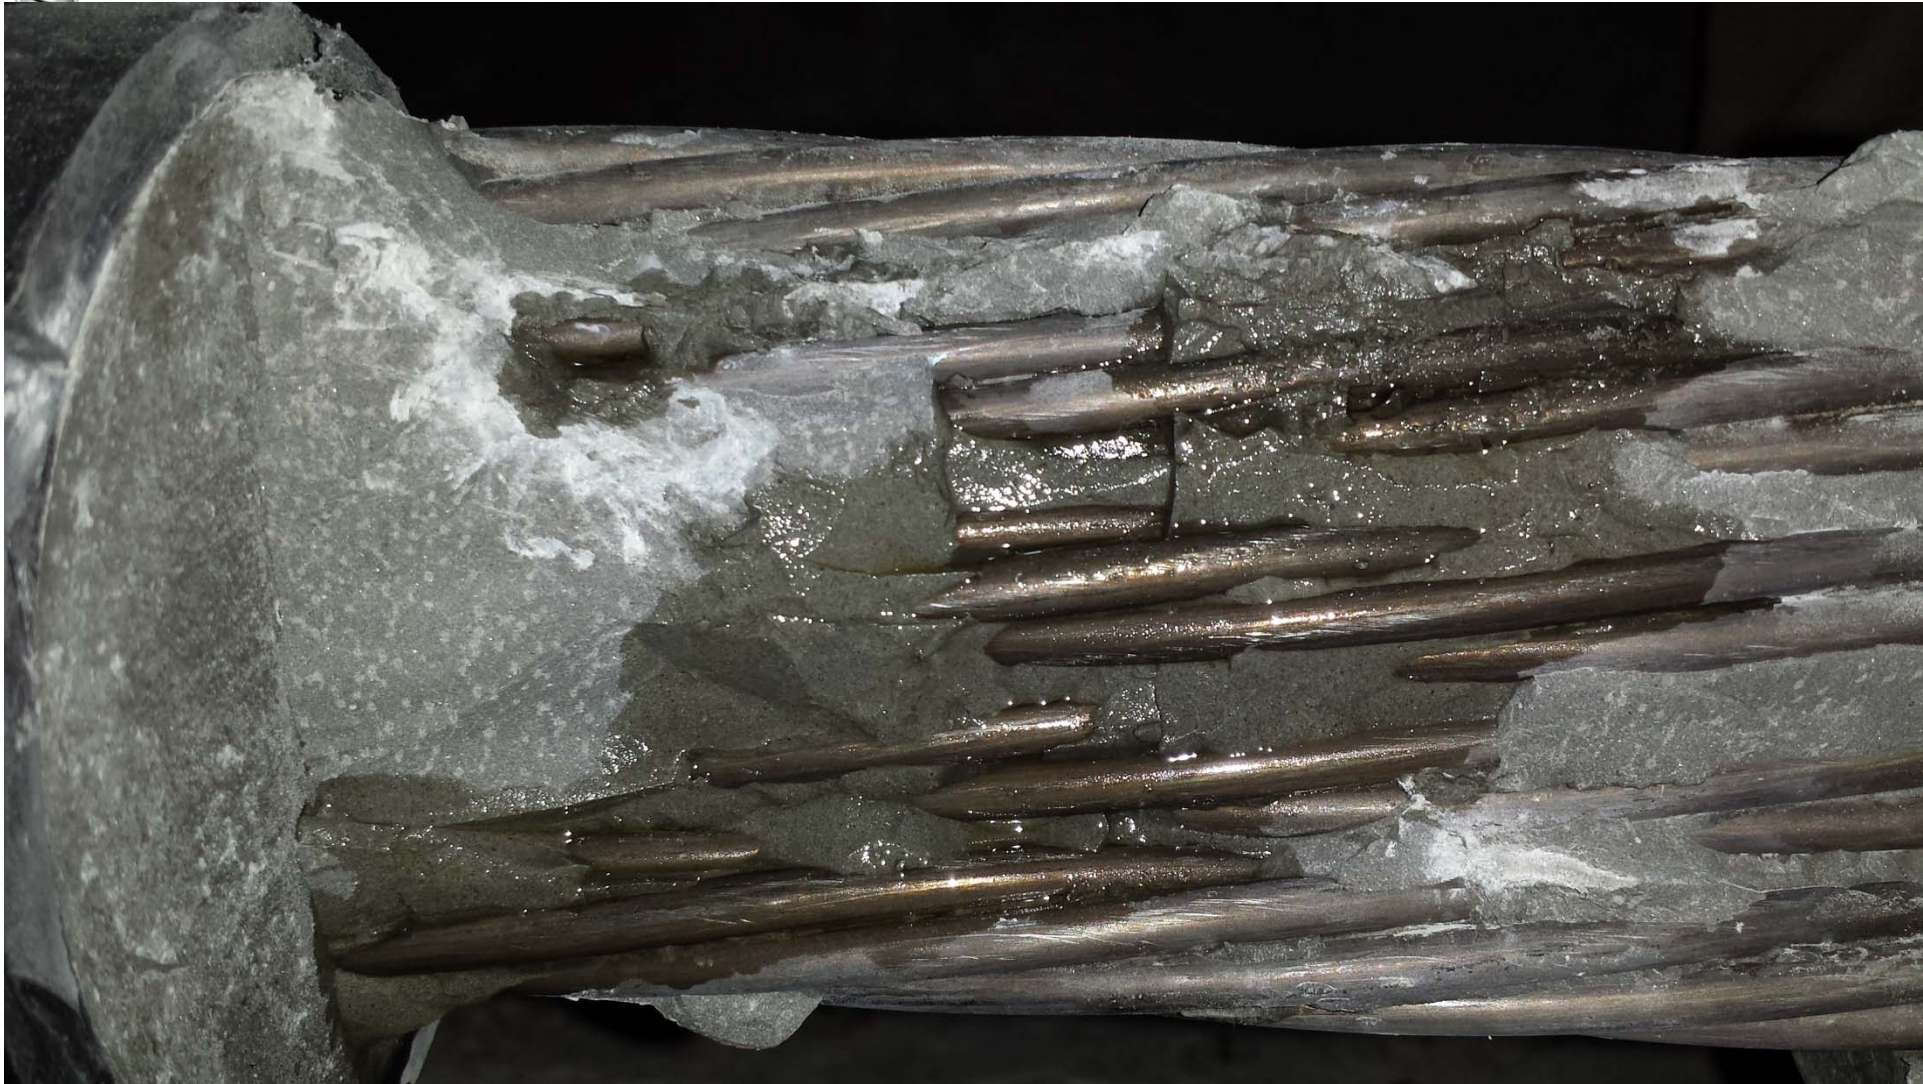
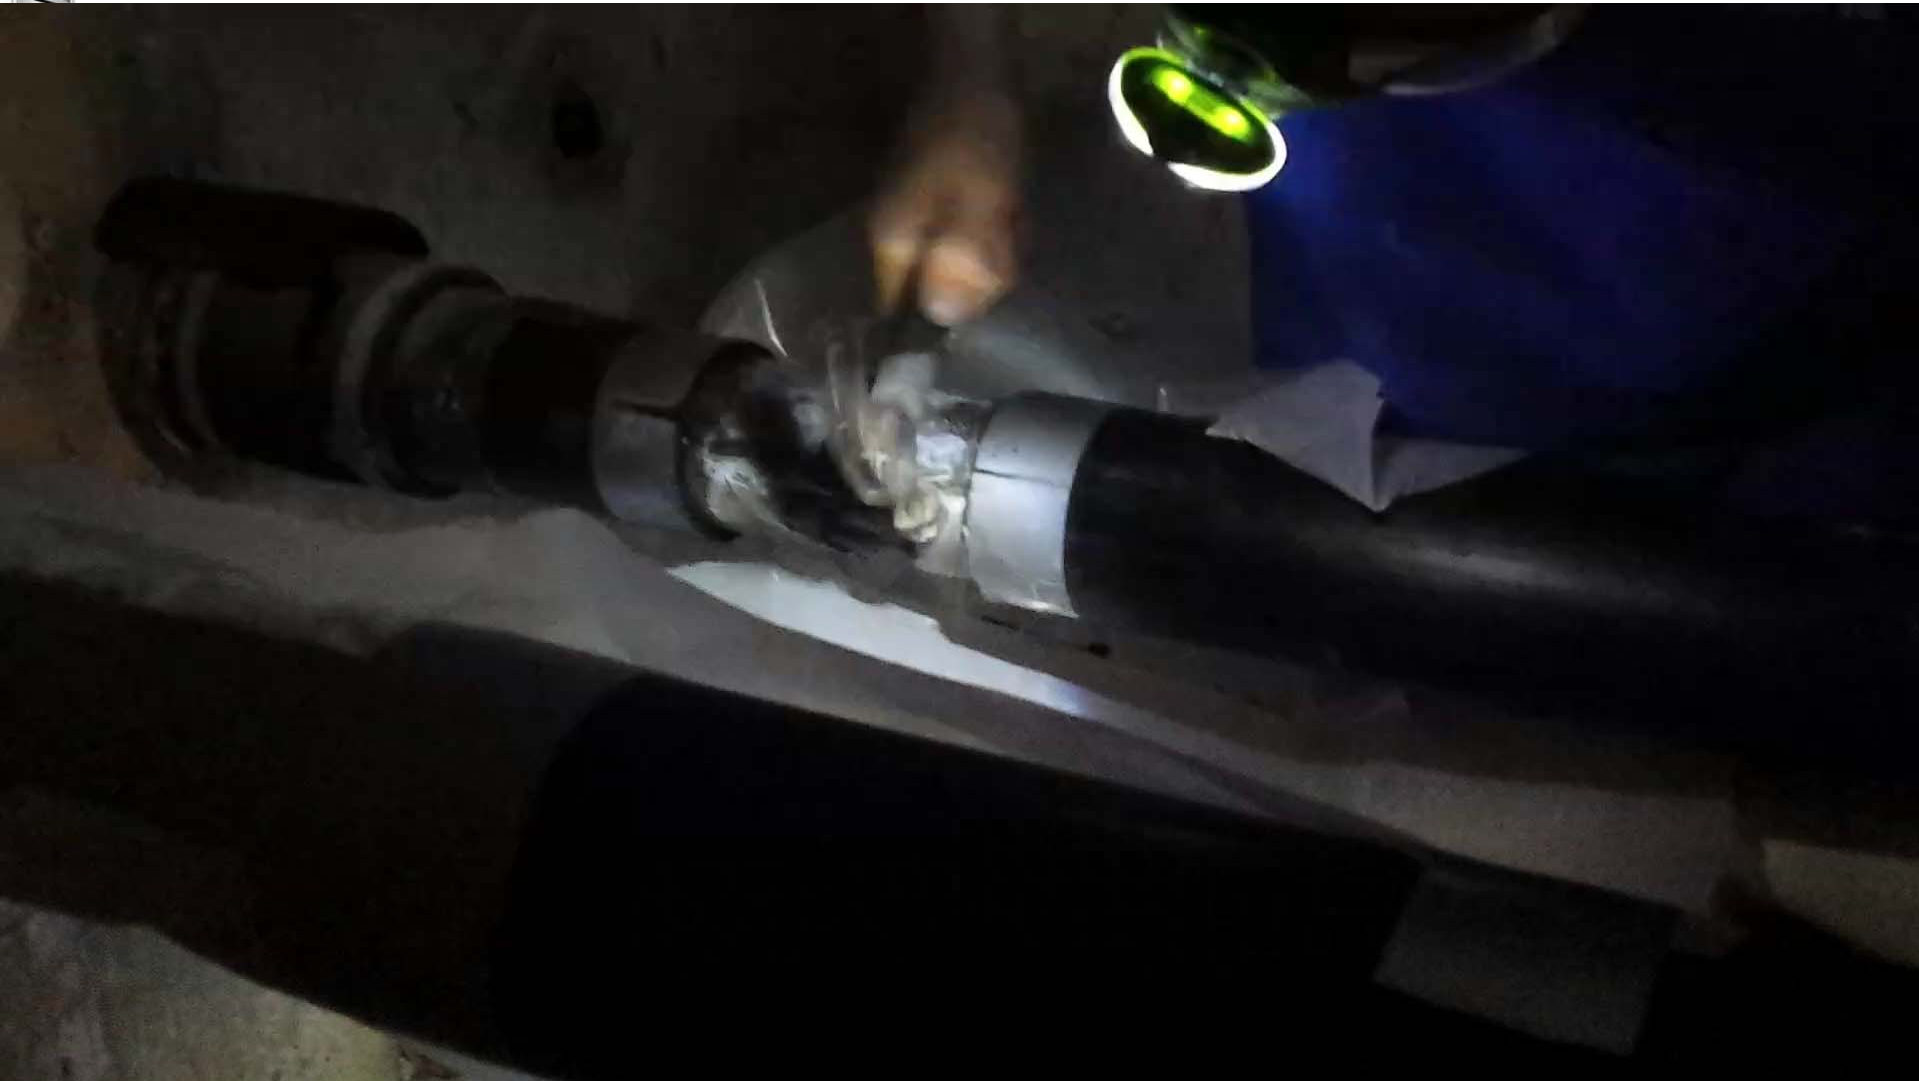
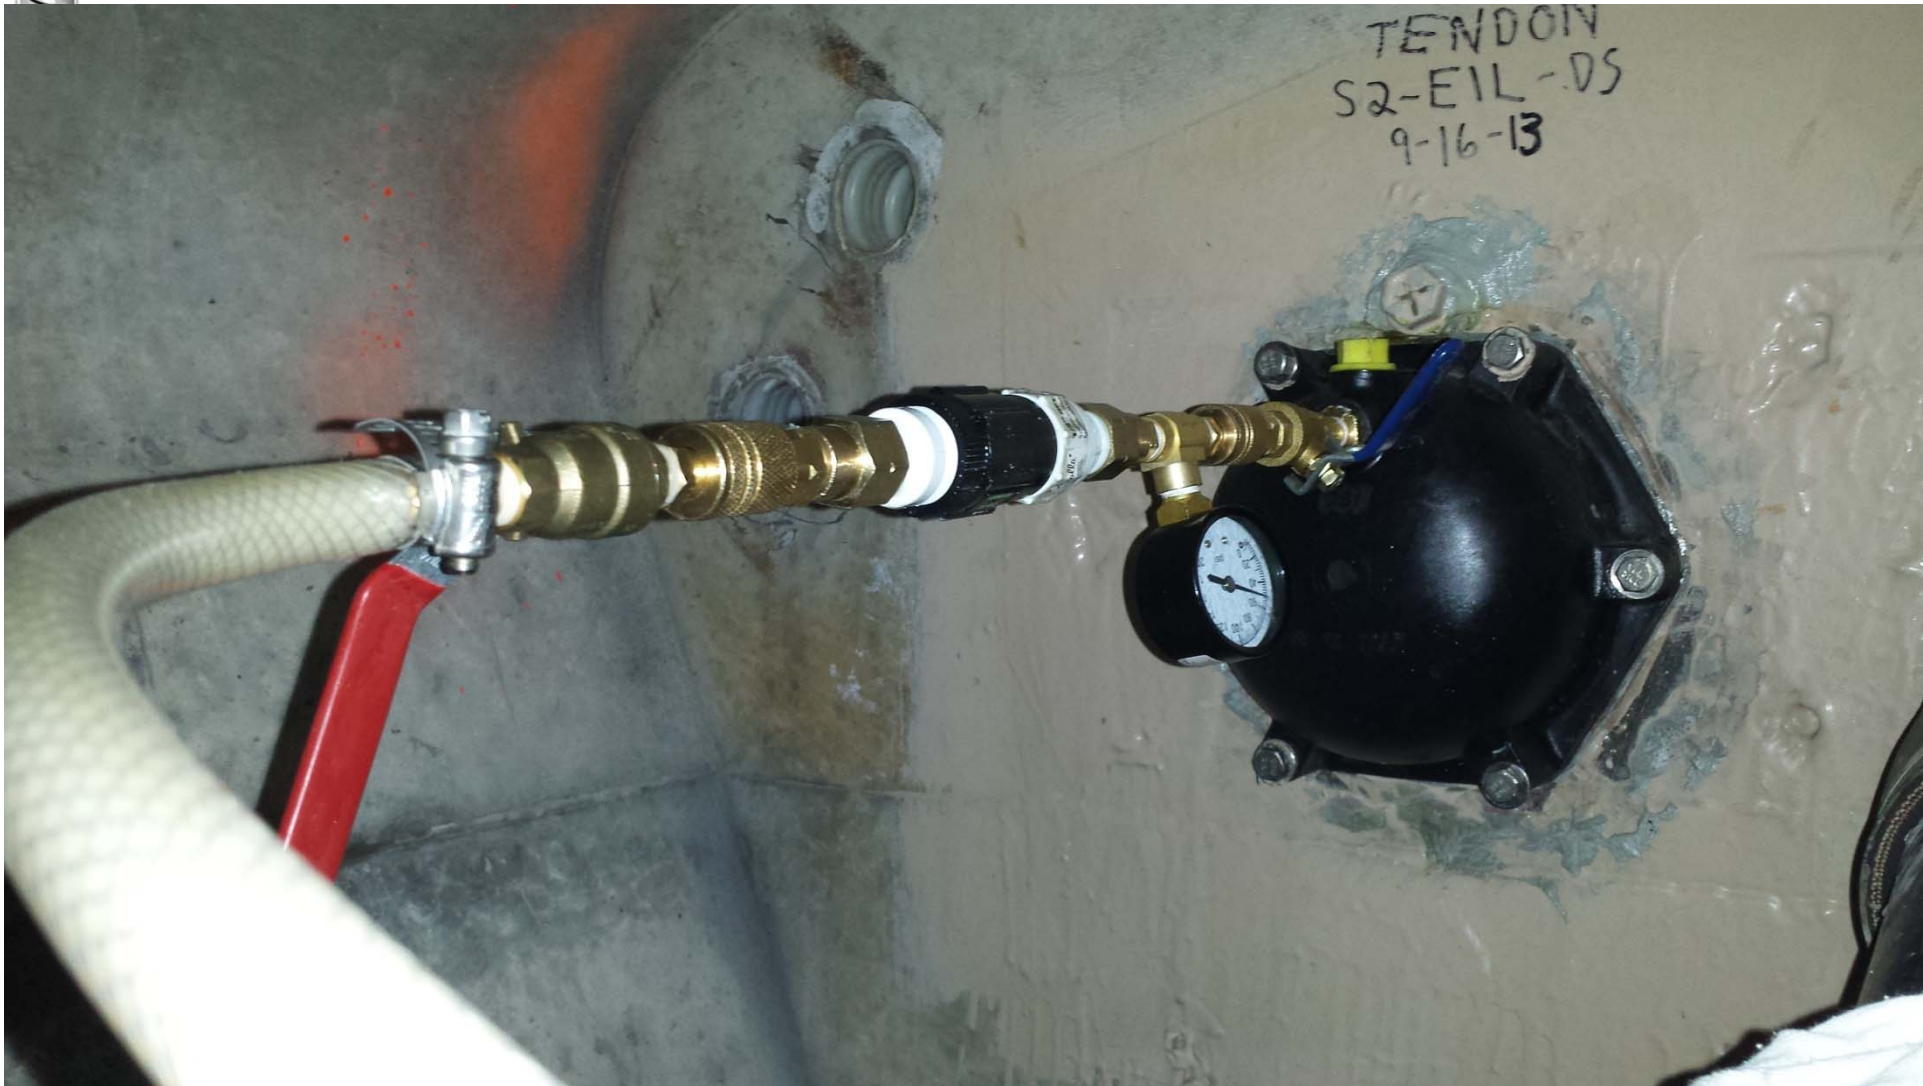
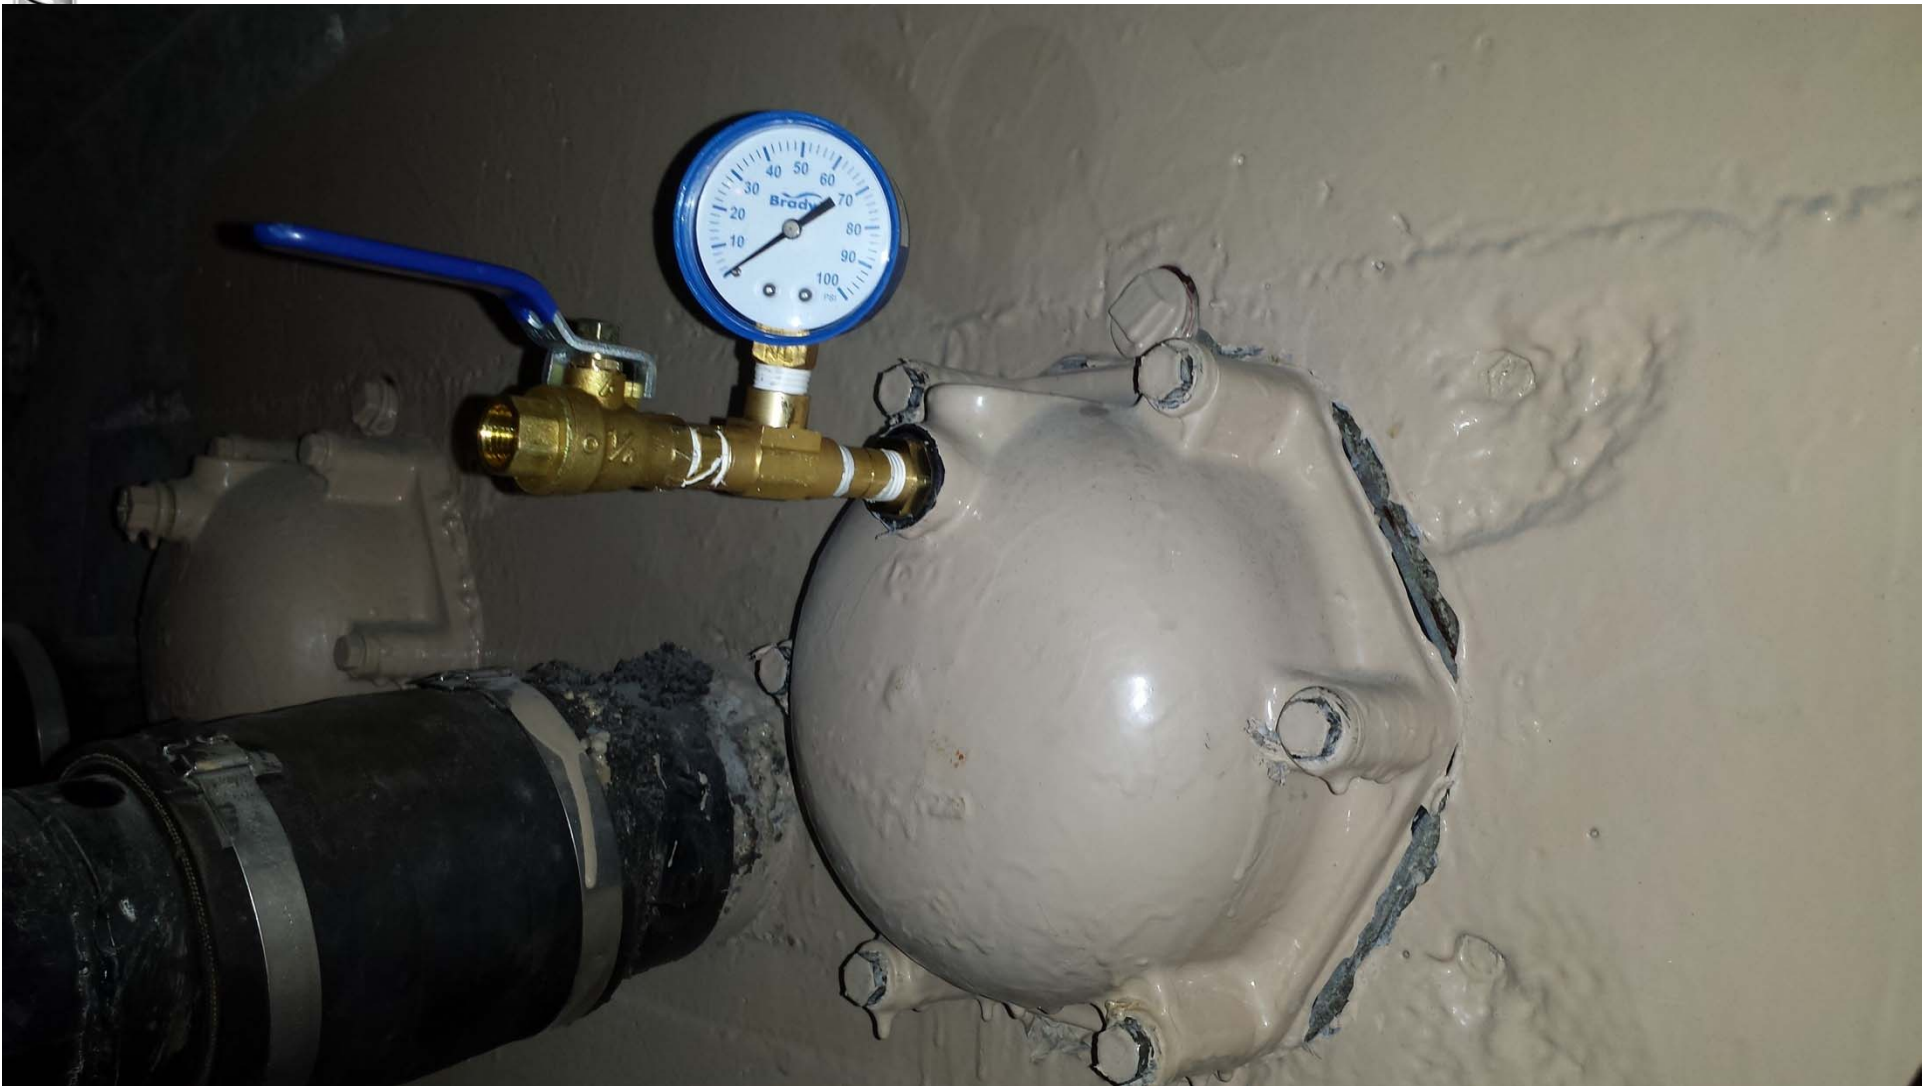
# Six Months later

Impregnation material is still evident after 6 months

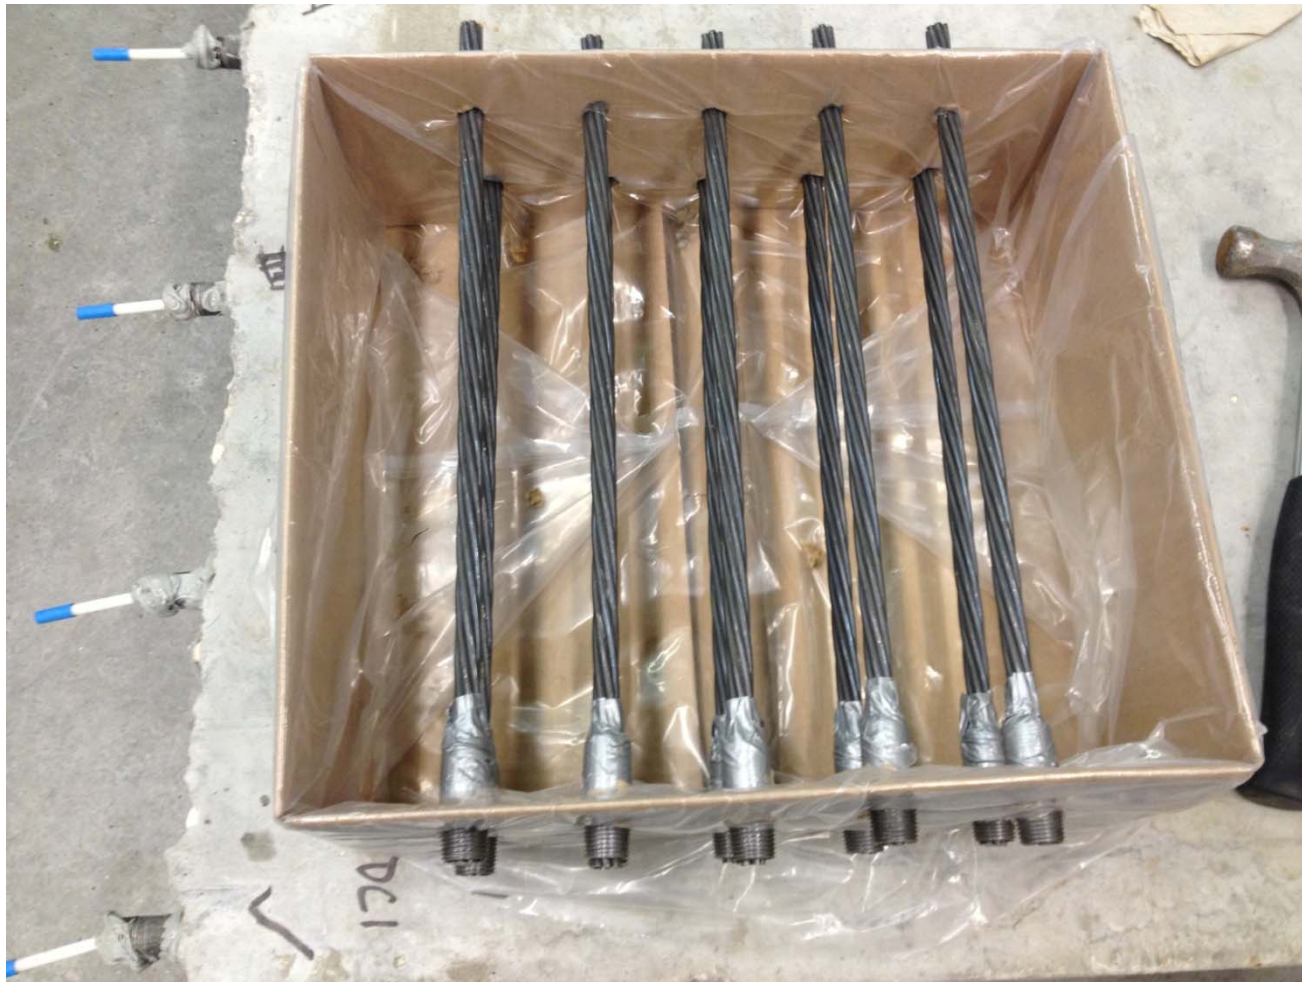
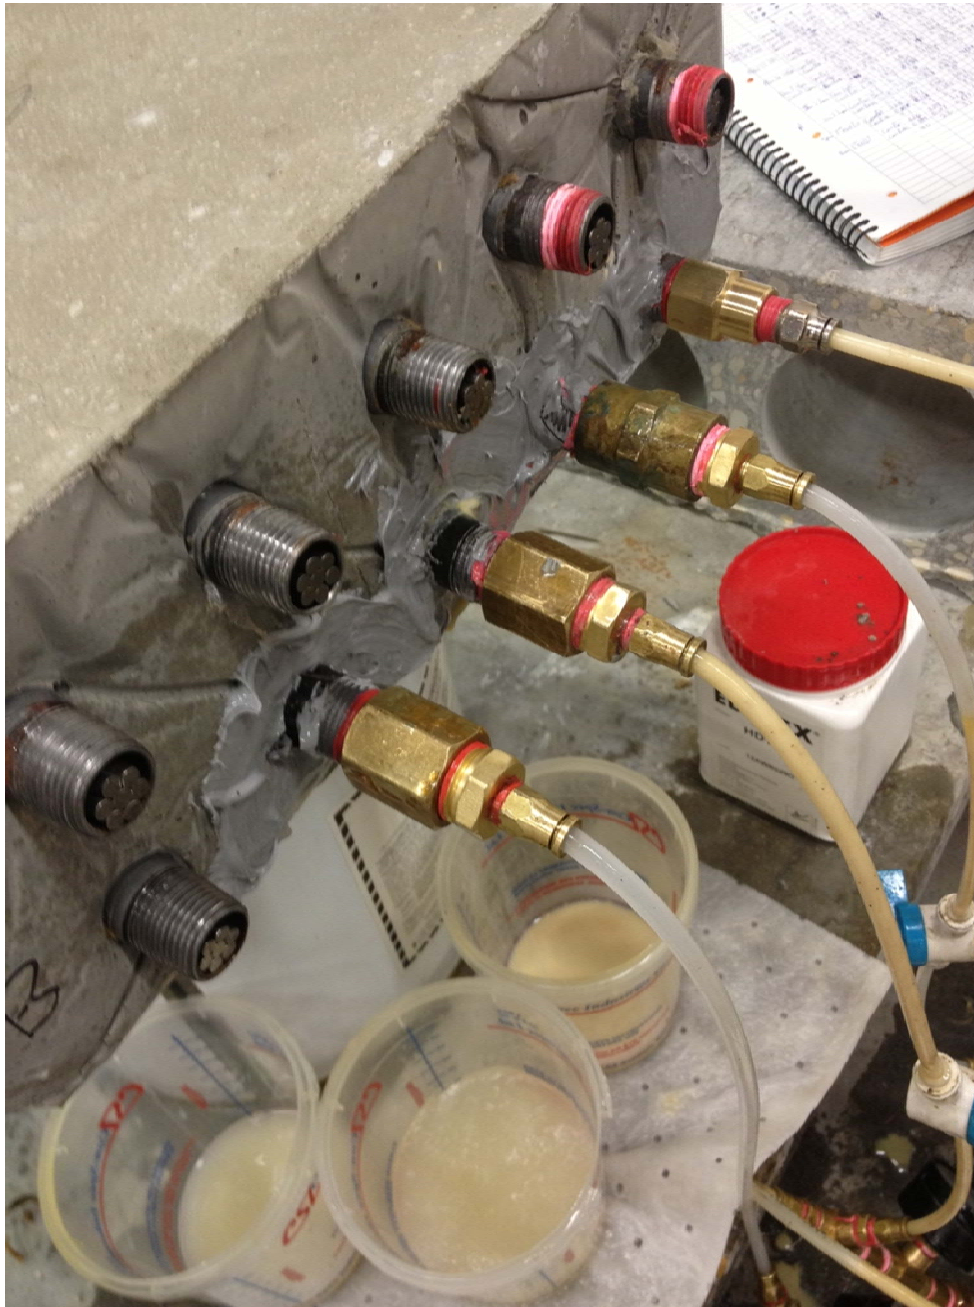
# Corrosion Rate Test Specimen

# Test Specimen Injection
