# Corrosion Protection of Grouted Post-Tension Tendons

Garth Fallis, P. Eng.

Vector Corrosion Technologies

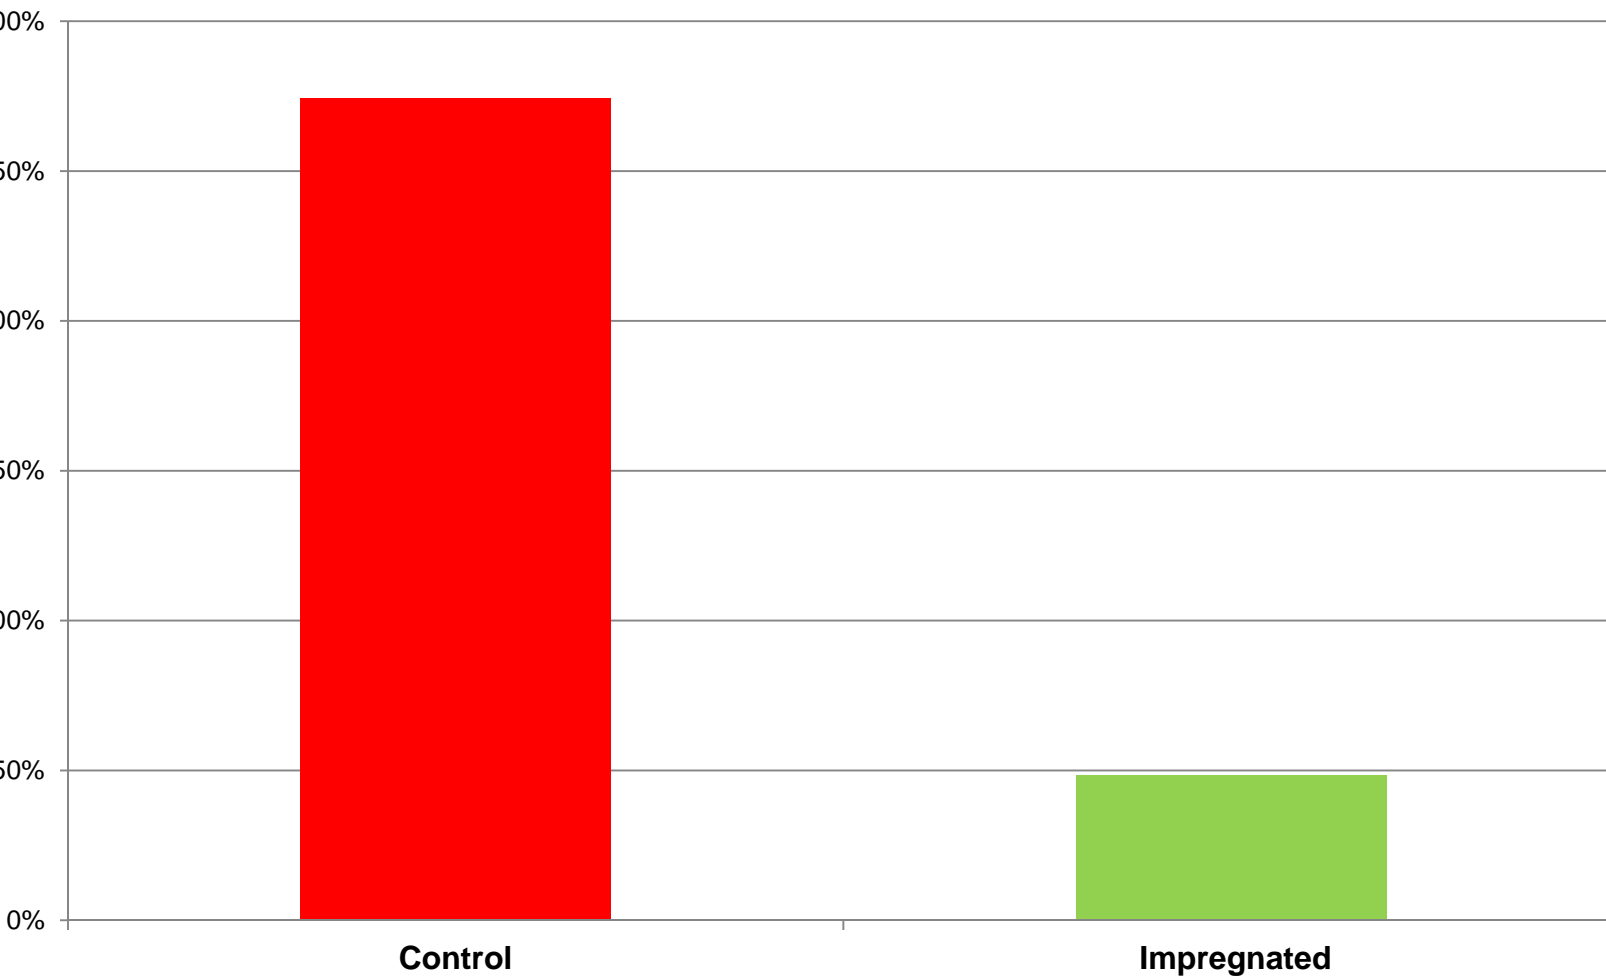
# Average Percent Change in Corrosion Rate

4 Days After Wetting Test Specimen

Impregnation material shows corrosion mitigation in laboratory testing
