San Francisco-Oakland Bay Bridge: Post-Tensioned solution for retrofit of broken bolts

Location: PTI convention / Norfolk, VA
Date: May 5th, 2014

Presented by: Michael Schwager, P.E.

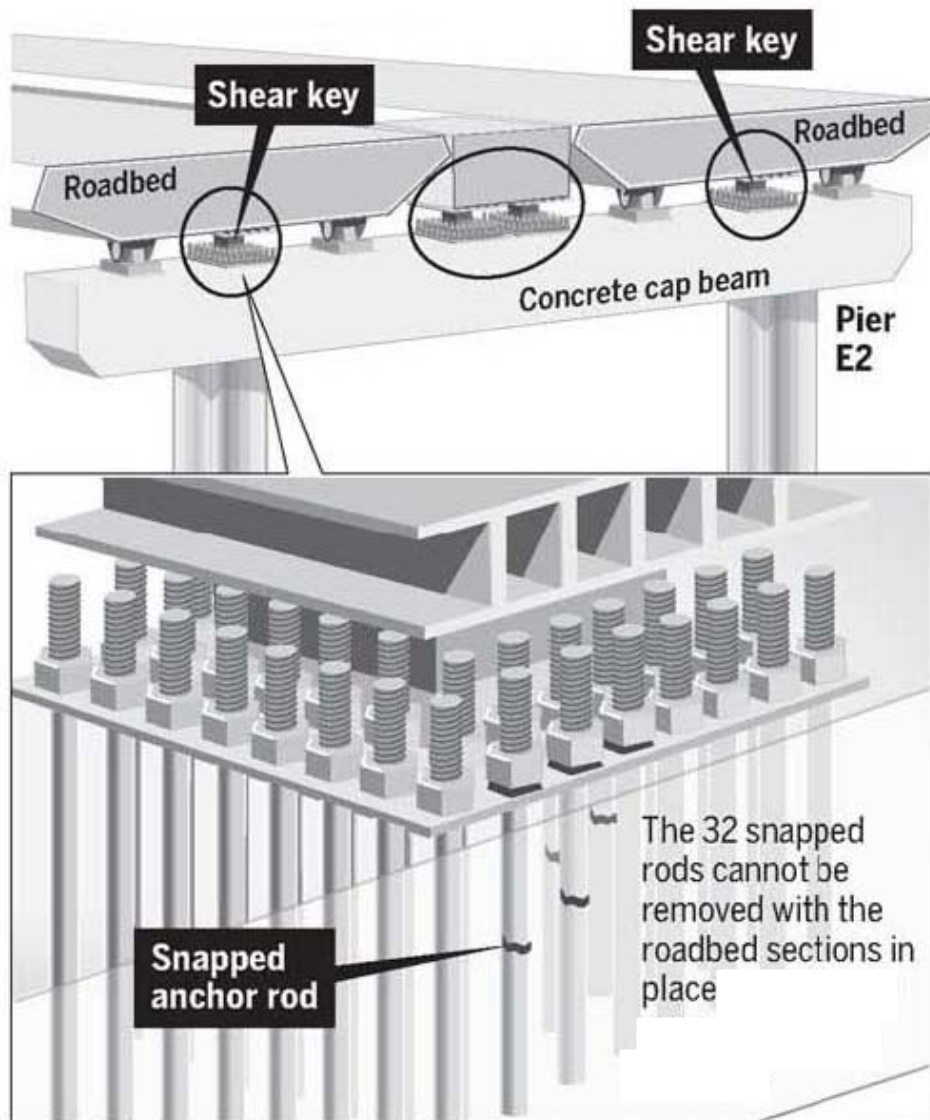
E2 Bar Quantity Summary

24 bars per bearing
48 bars per shear key
288 total bars
32 fractured bars

Broken rods

“On March 1, workers began stressing the 96 rods fabricated in 2008 for the two shear keys; between March 8 and March 15, 32 fractured rods were discovered.

Engineers and metallurgists have determined that the bolts broke due to hydrogen embrittlement, which requires a source of excess hydrogen, susceptible material and tension. Ongoing metallurgical analysis revealed that the bolts were susceptible due to the steel being harder on the outside than in the middle, or a lack of uniformity in the steel’s microstructure. The steel also showed low toughness and marginal ductility (the ability to stretch).

The excess hydrogen caused the threaded areas to become brittle and fracture under high tension when the bolts were tightened. An ongoing investigation is looking into the source of the excess hydrogen, which may have been both internal (i.e. residual from production) and/or external.”
