Christopher Fulton, B.Sc.(Eng.)
Lindsey Tourand, P.Eng.
Parsons Brinkerhoff Halsall Inc.

Goal of the study was to answer:

# The Study

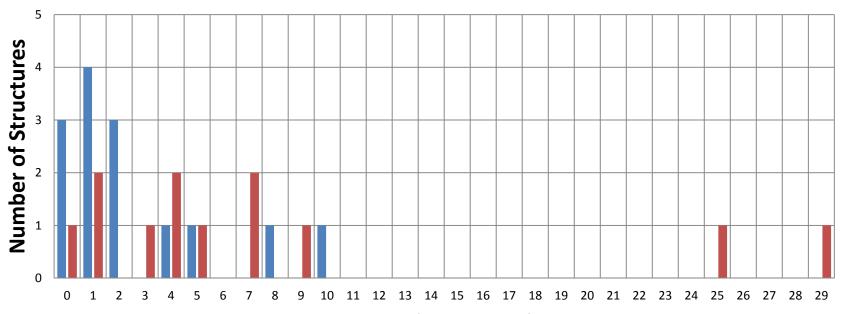
#### **Average Annual Wire Breakage Rate by Structure Type**

**Average Annual Wire Breakage Rate**

■ Hi-Rise Structure

■ Parking Structure

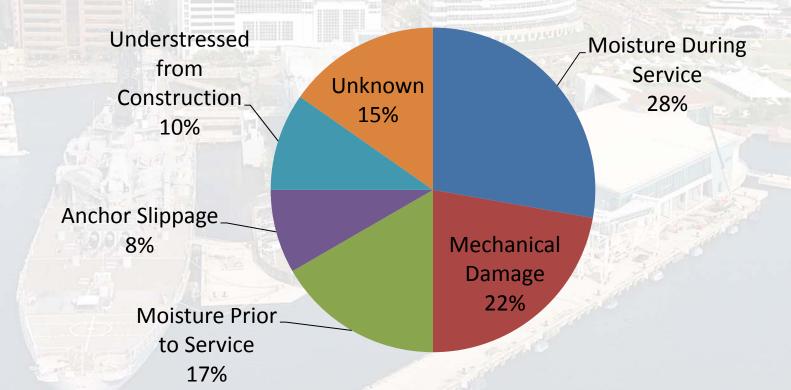
Causes of Post-Tensioned Tendon Failures in Interior Spaces (72 Tendon Sample Size)

Large percentage of PT tendon failures are the result of moisture entry or mechanical damage during service. These failures can be mitigated through regular preventative maintenance
